# **GOLDEN GATE BEAUTIFICATION M.S.T.U.**

# **NOVEMBER 19, 2024**

Project: GOLDEN GATE BEAUTIFICATION, M.S.T.U. Land

Landscape Architect Report: November 2024

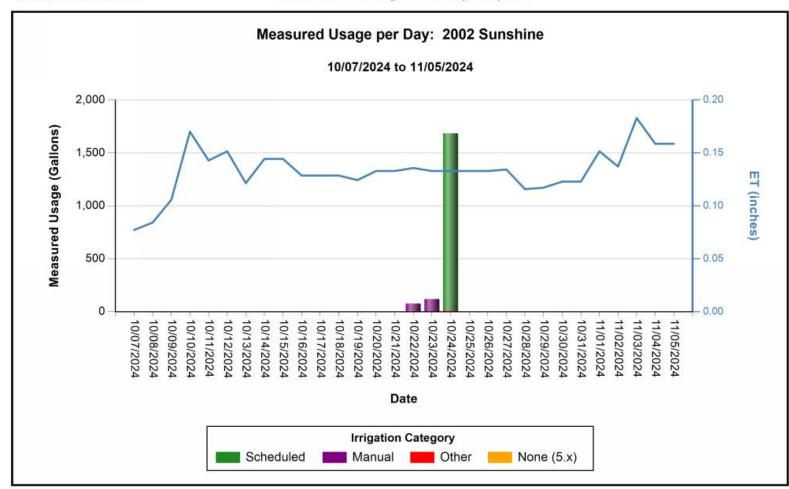
## Single Controller Measured Usage History Report

LOCATION/WORK AREA	<u>AC</u>	<u>S</u>	<u>C</u>	<u>R</u>	MAINTENANCE SERVICES OBSERVATIONS & RECOMMENDATIONS	RESPONSE or COMMENTS
						replanting's will require truck watering at planting and for a period of establishment.
					QUARTERLY ADDRESSED	
Accent/Street Lighting	Х				It is recommended all lights be reviewed for cleaning or replacements if needed. Some fixtures appear to have hazy and/or dirty lenses which reduces light levels.	
Lighting Electric Meters & Irrigation Controller Electric Source Locations					Lighting Electric Meter 2271 Sunshine Blvd., 1 SUN, Alley off 23 <sup>rd</sup> Ave. SW Lighting Electric Meter & Irrigation Controller Electric, 1995 Sunshine Blvd., 2 SUN, Alley off 20 <sup>th</sup> PL. SW Lighting Electric Meter 4642 18 <sup>th</sup> Pl. SW, 3 SUN, North R/W	
Fertilizations:			Х		Refer to schedule.	
Irrigation:		X	X		Previous month water use total per WeatherTrak controller estimate 1,877 gallons.  Controller water monitoring and/or operation appears to be not functioning properly. Turf areas appear to be a little water stressed but shrubs did not appear to be water stressed.

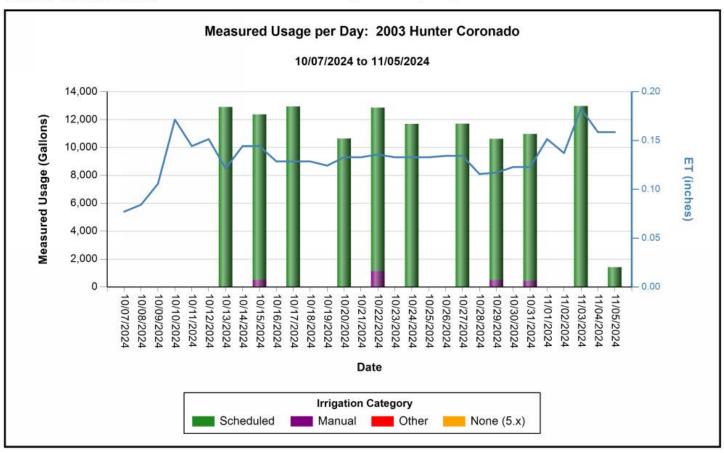
Single Controller Measured Usage History Report

QUARTERLY ADDRESSED	
Fertilization:		X	Х		All locations with perennial peanut planting shall have a Legume Soil Inoculant product applied as soon as possible, as well as an application of 0-0-22-22S-11mg fertilizer.	
		X	Х		Refer to FY23-24 recommended schedule.	
General Irrigation:					Previous month water use total per WeatherTrak controller estimate 121,041 gallons.
